Richmond Refinery LPS Bulletin – Reliability

HNC F-1551 DeNOx Module Plugging

Location: Hydroprocessing Division, RLOP - Heavy Neutral Cracker (HNC)

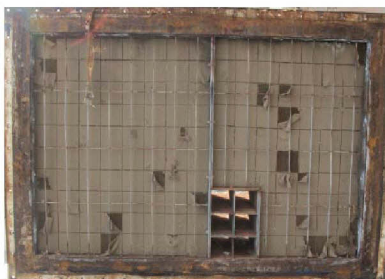
DeNOx Module Dirty Inspection.

Note an almost complete coverage of the inlet surface area of fine fibers.

- 1) Significant debris was found (which was believed to have come from plant start up) were directed through the DeNOx, which caused plugging.
- 2) Equipment with a single point of vulnerability for a unit should be analyzed for degradation in alignment with the shutdown frequency interval in order to help better predict the probability of failure.
- 3) DeNOx plugging has occurred in other facilities in a similar manner.

- 1) Modify start-up procedures to protect DeNOx module from debris.
- 2) Adjust the timing of the performance analysis of DeNOx modules so that they are aligned with the shutdown frequency/schedule.
- 3) Generate a DeNOx Best Practice to provide recommendations and help share experiences through the Manufacturing system.

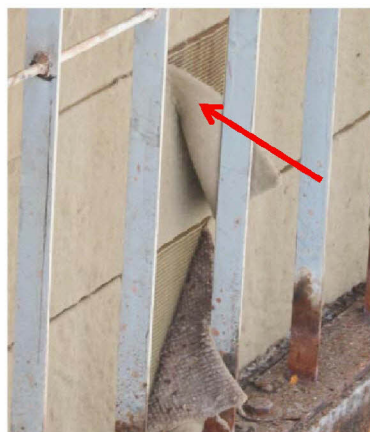
Example of material found on inlet face to DeNOx shown to be matted together following the contours of the catalyst clusters.
